Working to Fix the Huygens Relay Link

Les Deutsch

Jet Propulsion Laboratory

February 15, 2001

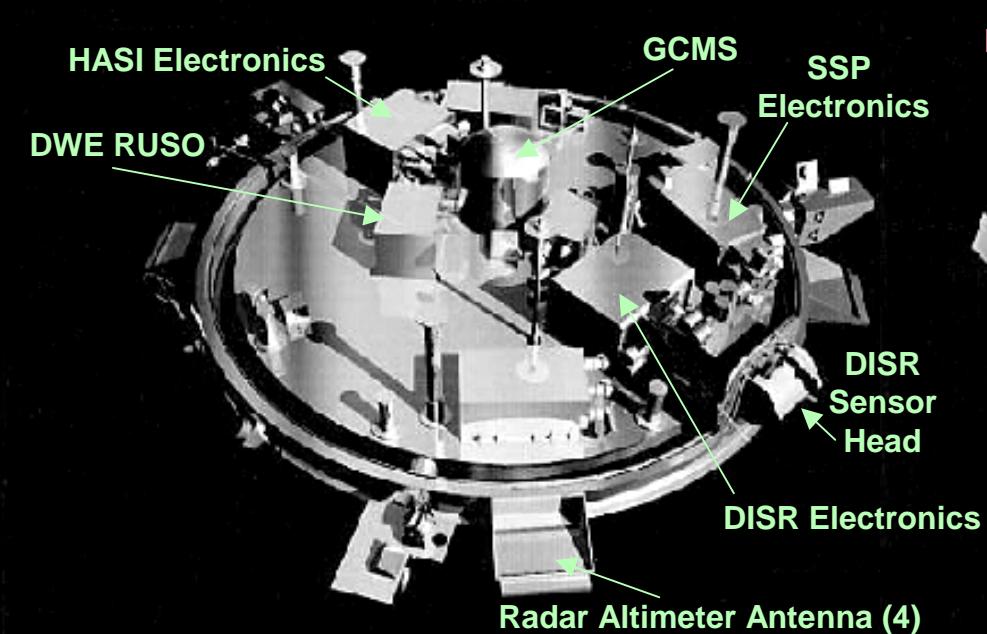
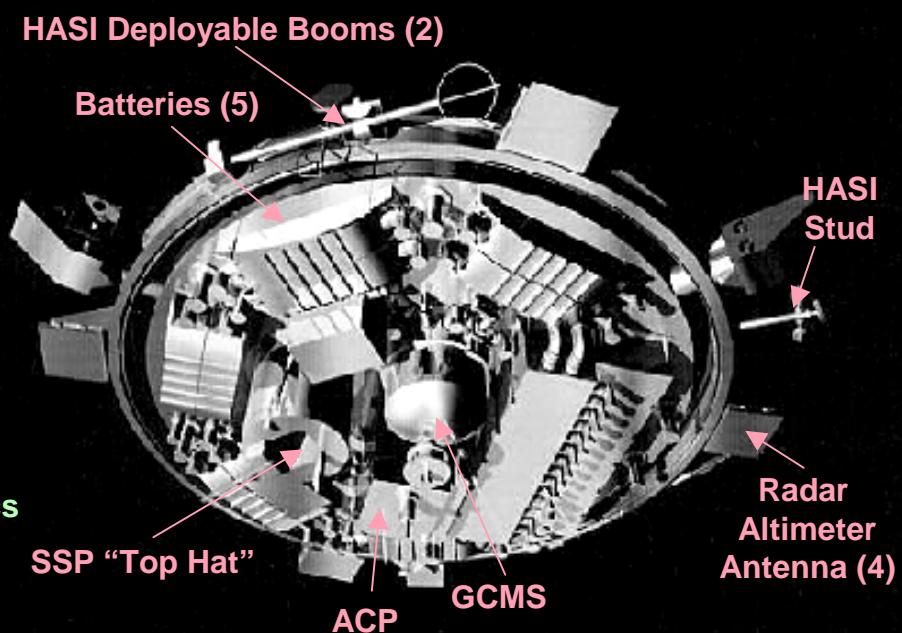
Huygens Titan Probe

Upper Side

Bottom Side

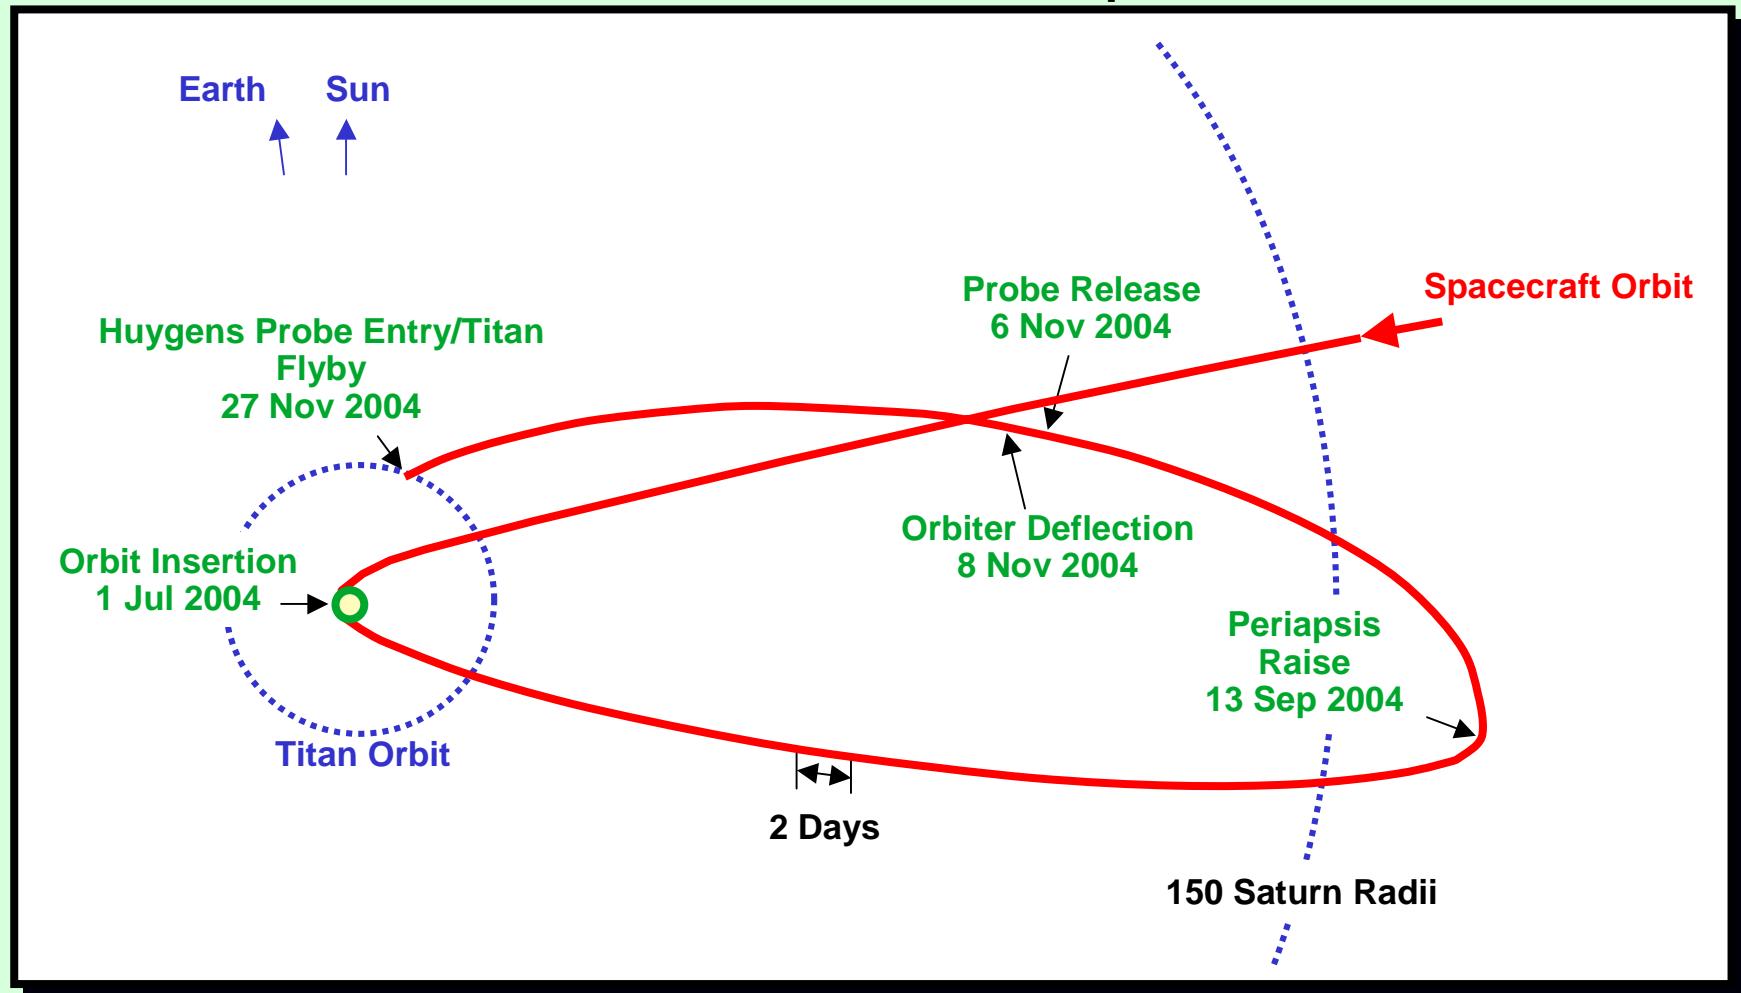
Saturn Arrival and Initial Orbit

View from Saturn north pole

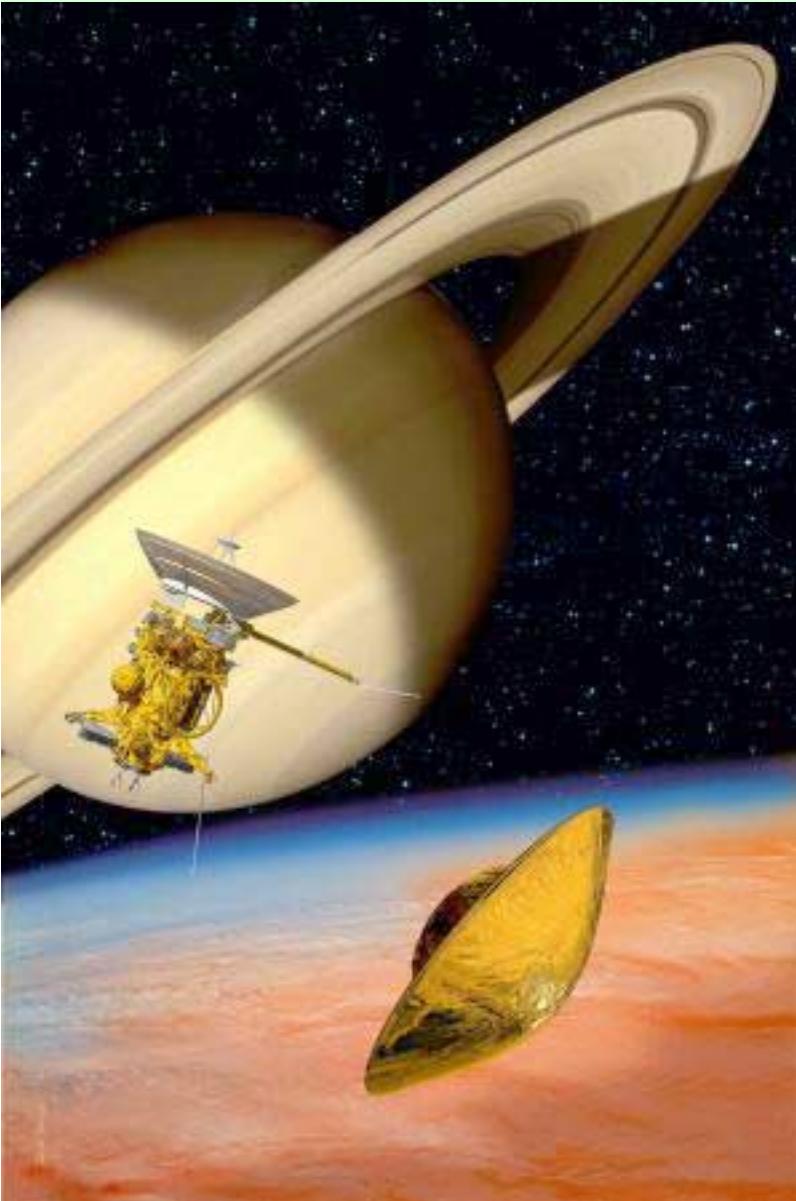
Working to Fix the Huygens Relay Link Probe Communications System

- Probe instruments generate fixed length packets that are stored in two buffers
- Probe software gathers these packets into frames
 - Seven packets in each 8192-bit frame
 - Reed-Solomon encoding
 - Frame sync word and header added
 - Differential encoding
 - Convolutional encoding with alternate symbol inversion
- Frames are transmitted to Cassini on two S-band channels
 - Different carrier frequencies
 - One channel delayed by 6 seconds
 - Data rate fixed at 16Kbps, so 1 frame/second in each channel

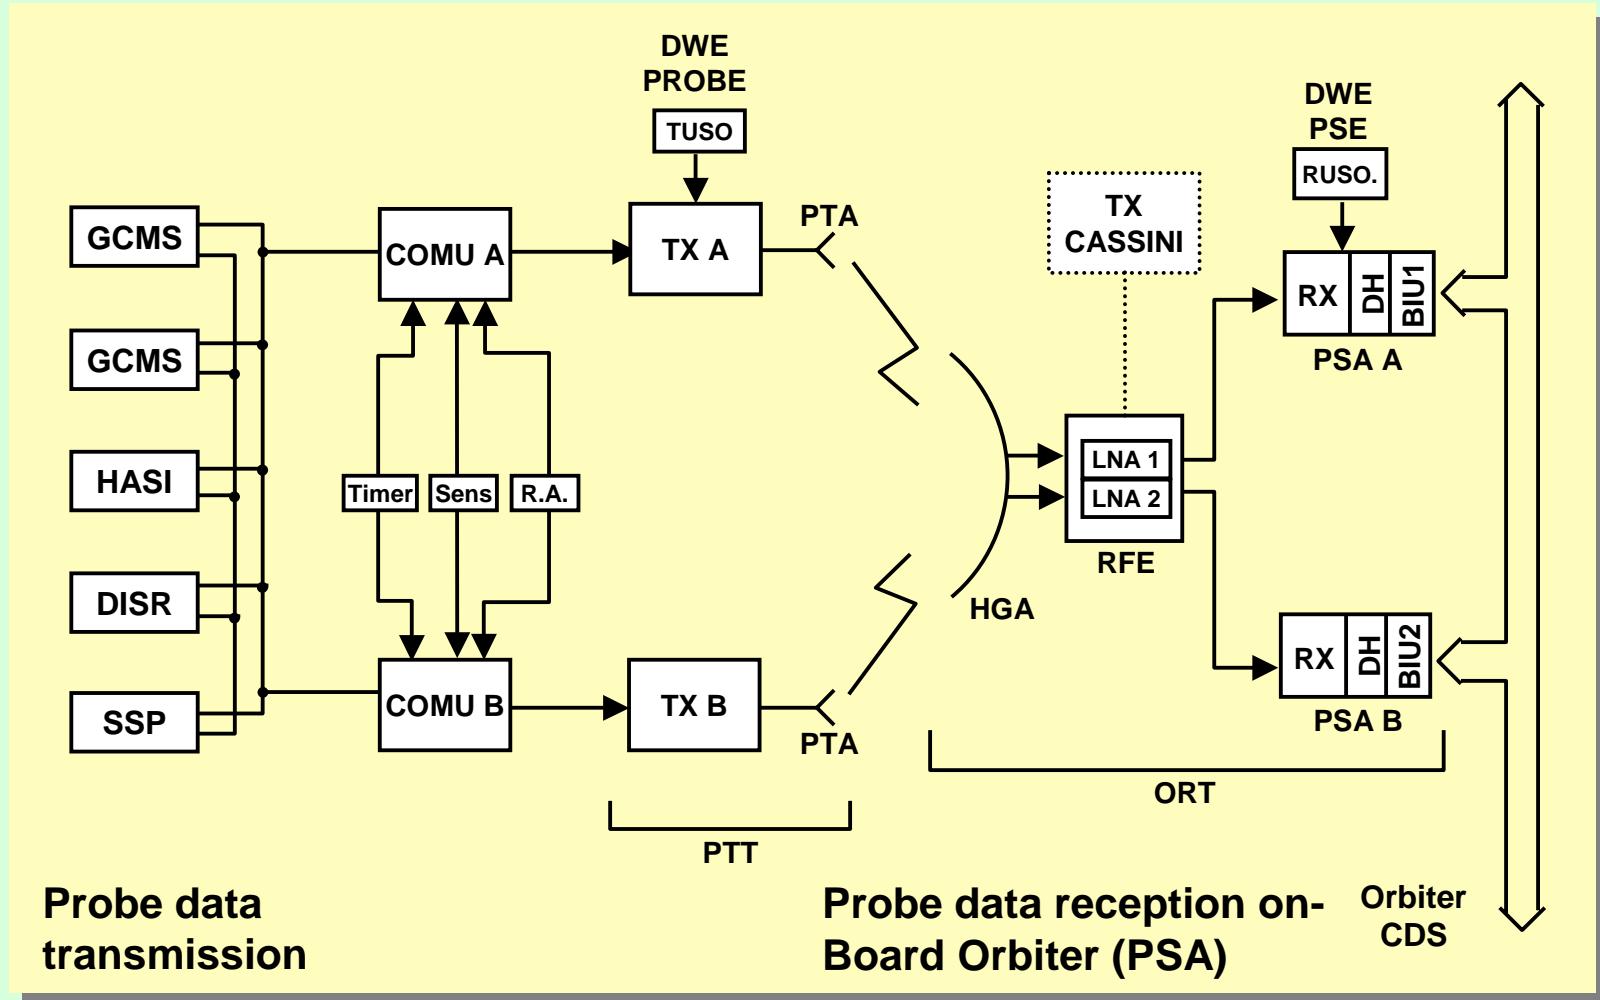
Working to Fix the Huygens Relay Link Communications Block Diagram

Probe data transmission

Probe data reception on-
Board Orbiter (PSA)

Orbiter
CDS

- The PSA on board Cassini receives the Huygens signals
- Carrier demodulation
- Subcarrier demodulation
- Bit detection (using classical DTTL)
- Viterbi decoding
- Frame sync
 - If in sync, frame is passed to Cassini CDH for further processing
 - If not, a dump packet is passed instead – no telemetry information
- Frame sync word stripped
- Remainder of frame is stuffed into a Cassini downlink frame and sent to Earth
- Housekeeping frames (with PSA status) are also sent to Earth

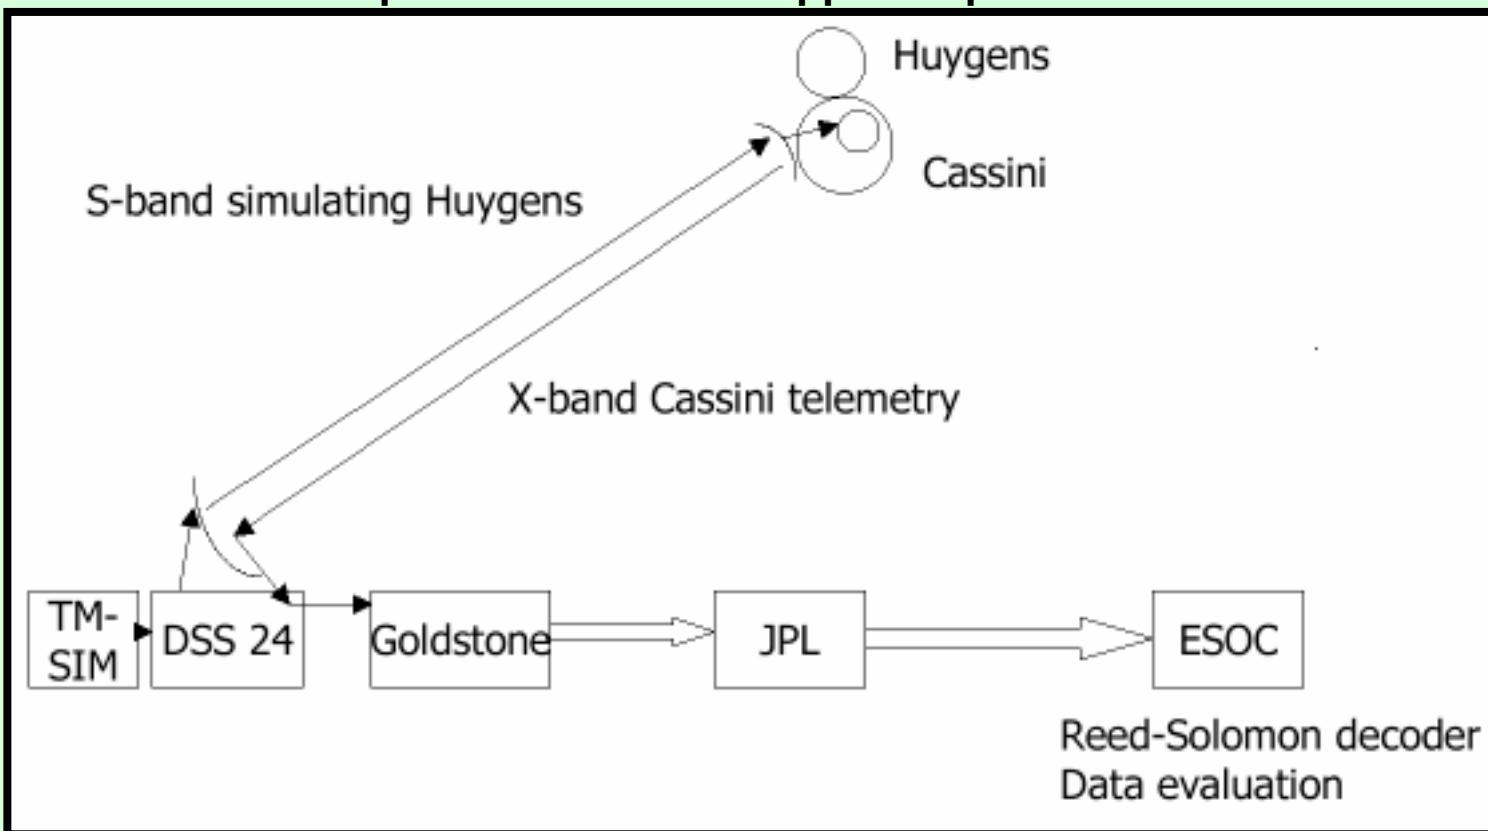
PRT 1: First DSN Ground Testing

- A Probe Relay Test (PRT) was performed in February, 2000 to determine the performance of the hardware and software aboard Cassini for supporting the probe, telemetry to the ground, DSN-ESA communications, and ESA decoders
- Test simulated expected maximum Doppler of probe mission

- Expected all frames over a certain SNR to decode correctly at ESOC
- In fact, the majority of frames did not even synchronize in the PSA
- Many frames that were sent to the ground failed to RS-decode at ESOC despite the fact they should have had plenty of SNR
- Analysis of test results (conducted by Boris Smeds of ESOC) indicated:
 - The PSA tracked the carrier and subcarrier as expected
 - The bit sync DTTL failed to track the data
- It was later confirmed by Alenia (the Manufacturer of the PSA) that incorrect values for DTTL loop bandwidth had been used in the design
- There is insufficient bandwidth in the DTTL to track in the higher-Doppler periods of the mission

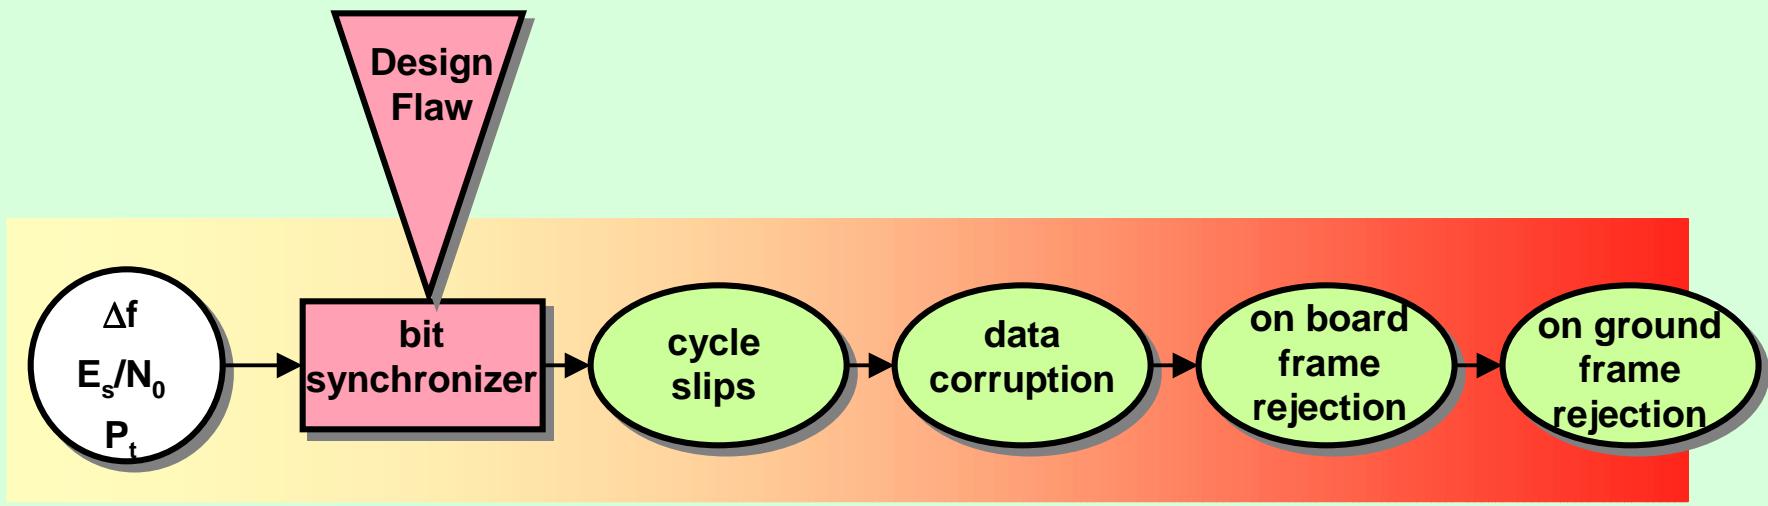
Working to Fix the Huygens Relay Link Failure Mechanism

Relevant
Parameters

The
Problem

The
Effect

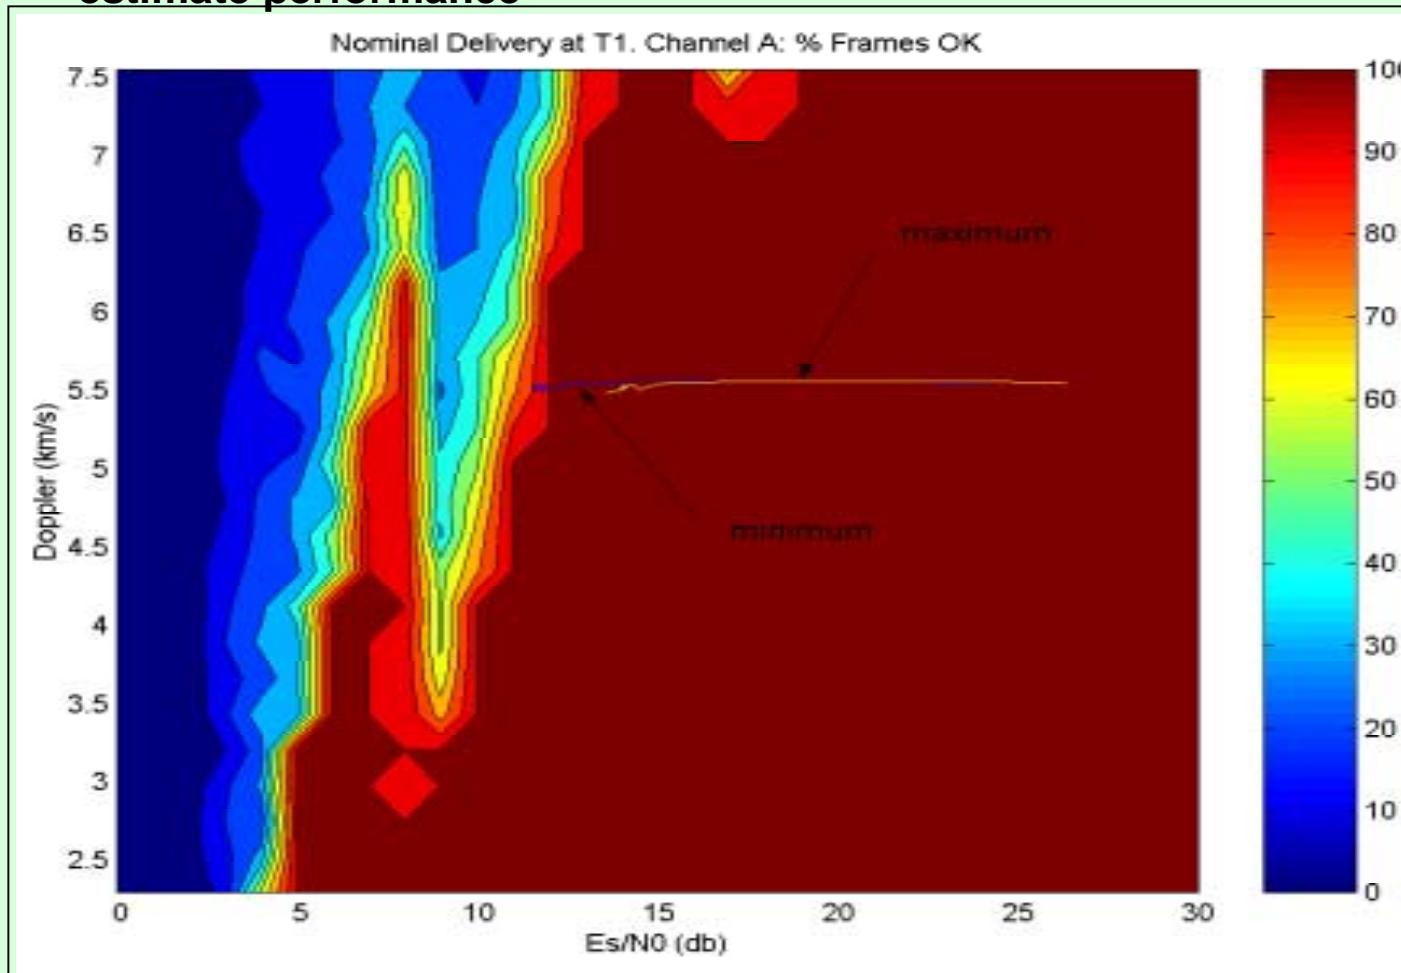
Working to Fix the Huygens Relay Link Bit Slip Function as a Contour - Channel A

- GMV has interpolated Boris' tables to get contour plots
- Various probe trajectories can be integrated against these contours to estimate performance

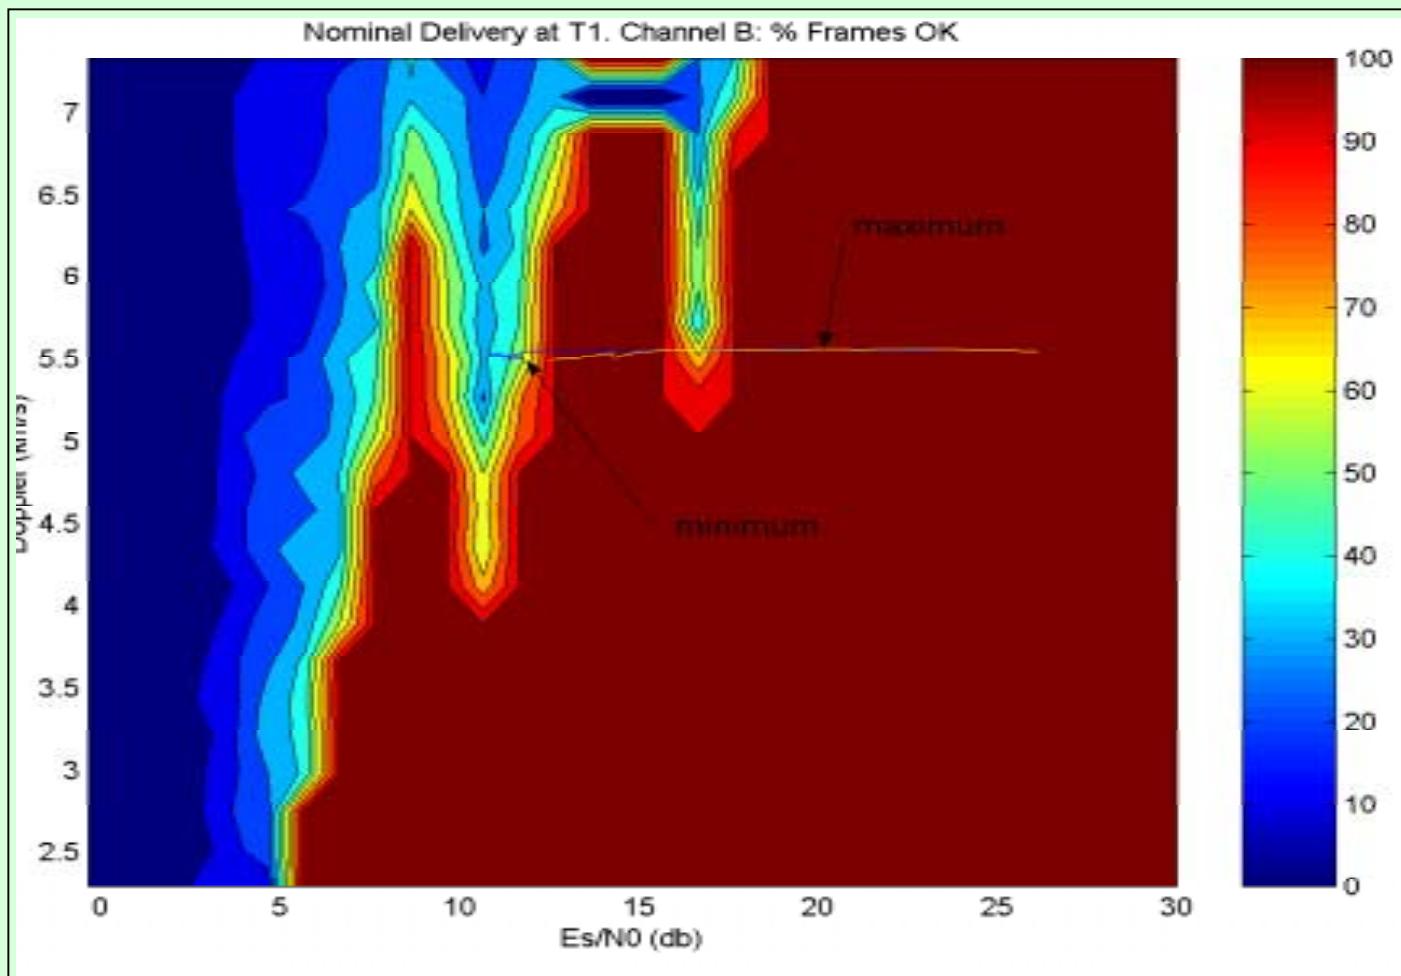
Working to Fix the Huygens Relay Link Bit Slip Function as a Contour - Channel B

- Similar information for Channel B

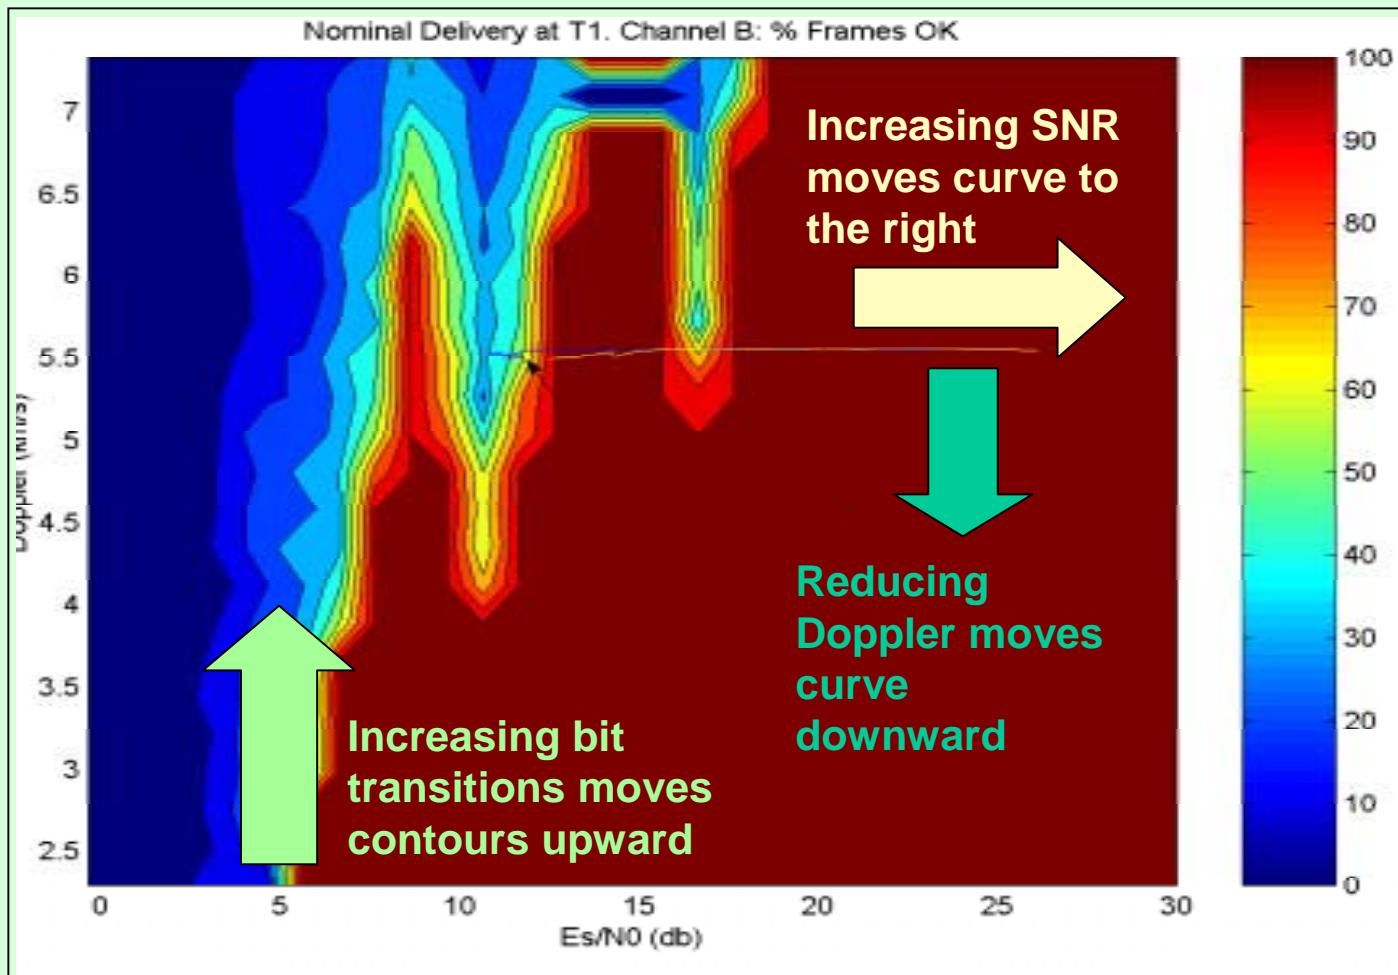
Ways to Improve Data Return

- Varying the critical parameters “moves” the probe curve with respect to the contours - resulting in more good data returned to Earth

- Change the Cassini tour so that it passes Titan at a much larger distance to reduce Doppler
- Reduce the relative time of arrival between Huygens and Cassini (ODT) to increase SNR
- Warm up the Huygens oscillator before releasing the probe to reduce frequency offset (equivalent to Doppler)
- Change Huygens entry point to increase SNR
- Gain knowledge of Titan's winds by delaying probe an orbit – allows better Cassini HGA pointing to increase SNR
- Put a CONSCAN algorithm on Cassini to increase SNR
- Insert “zero packets” in data stream to increase bit transitions
- Rewrite ESA’s RS decoder to recover more of the frames returned to Earth
- Use coding to increase bit transitions
- Use coding to absorb hits from anomaly

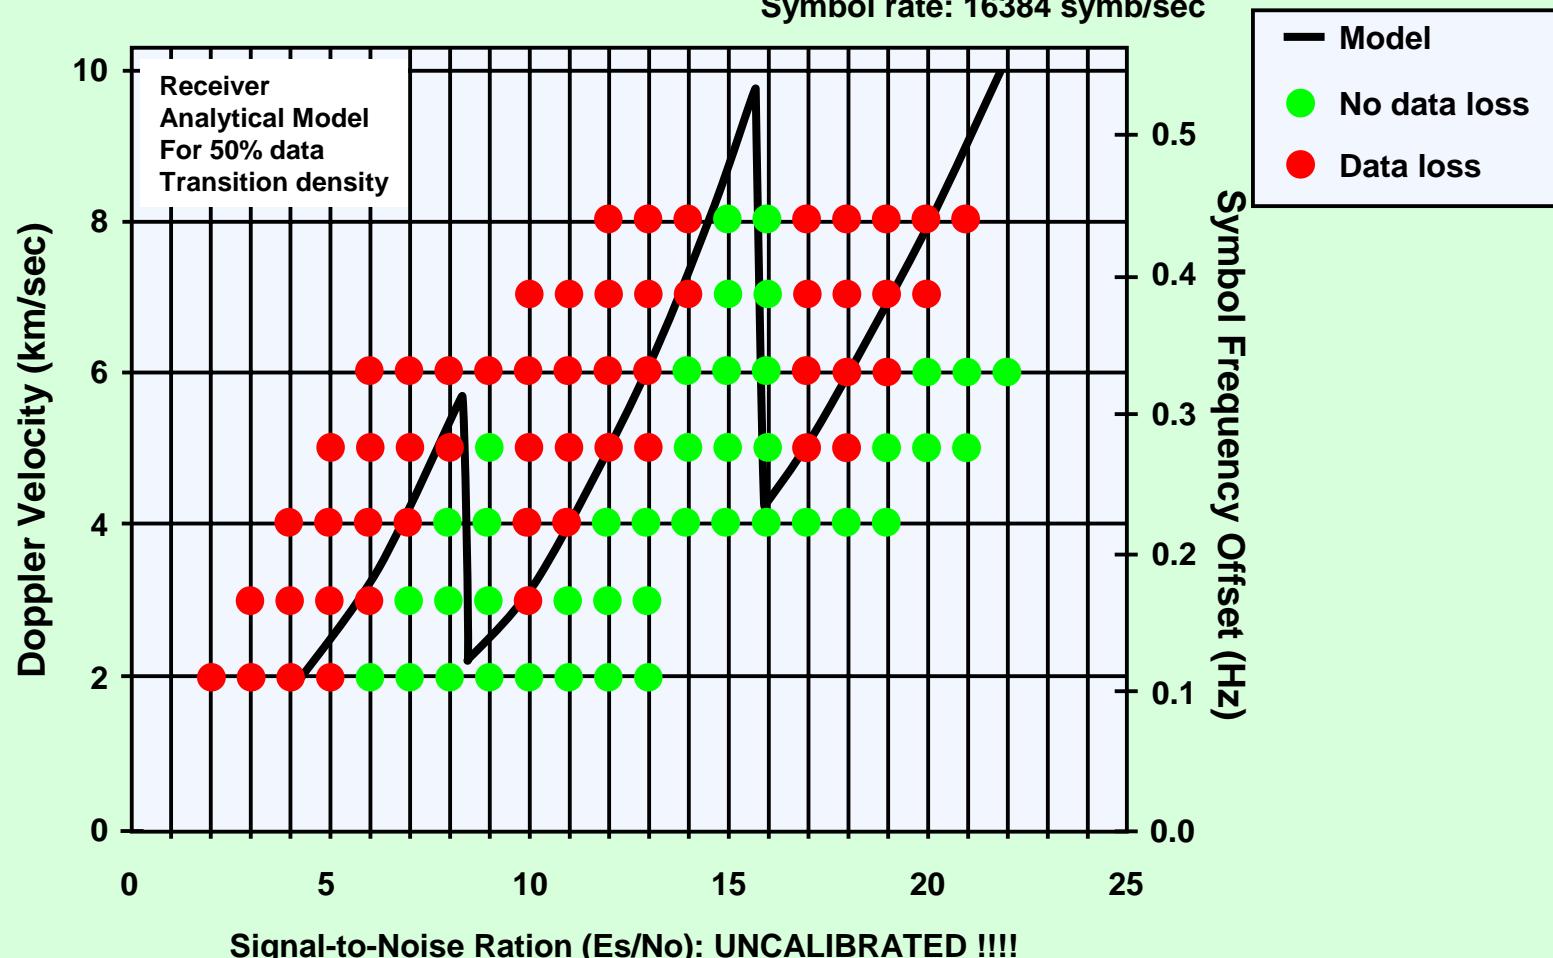
PRT 2 Preliminary Results

Channel A; 53% Data Transition Density

Symbol rate: 16384 symb/sec
